LOWER ENGLISHMAN RIVER
ENVIRONMENTAL - SOCIAL ASSESSMENT

Environmental Impact Study

Prepared for
Environmental Services Section
Land Management Branch,
B.C. Department of Environment
January 20, 1976

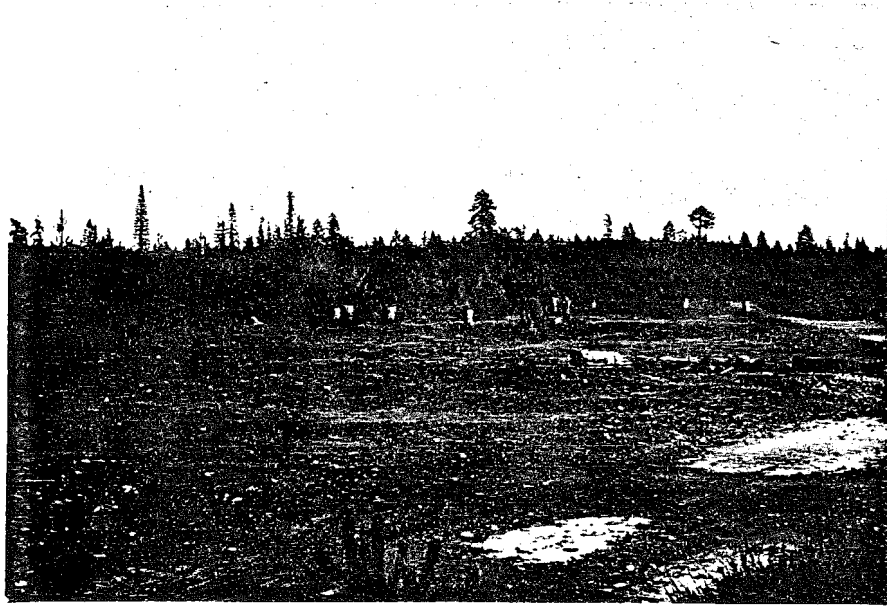
1

1. Depicts level nature of upper part of Allton property, and early coniferous growth
2. Bearberry - Douglas fir association is common on southwest part of property, and contains lodgepole pine as well. Note gravelly ground surface.
3. Uppermost cliff area, about $1/3$ below the Provincial Park. Note bedrock exposures near water level (shale) and fairly high river gradient.

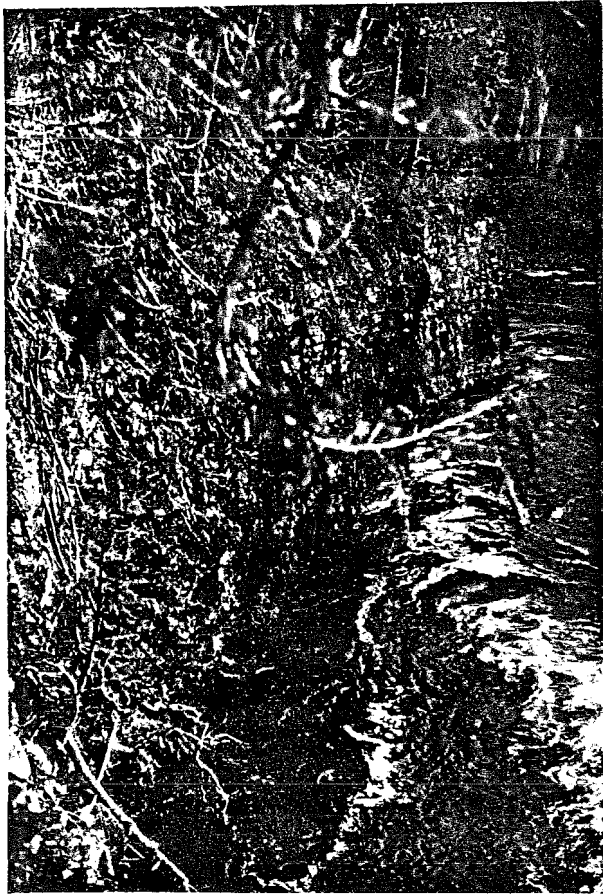
8

- 8-9. Predominantly bedrock cliff about 1¼ river miles below Provincial Park. These cliffs are quite stable, but there is some erosion of the glacial till above them.

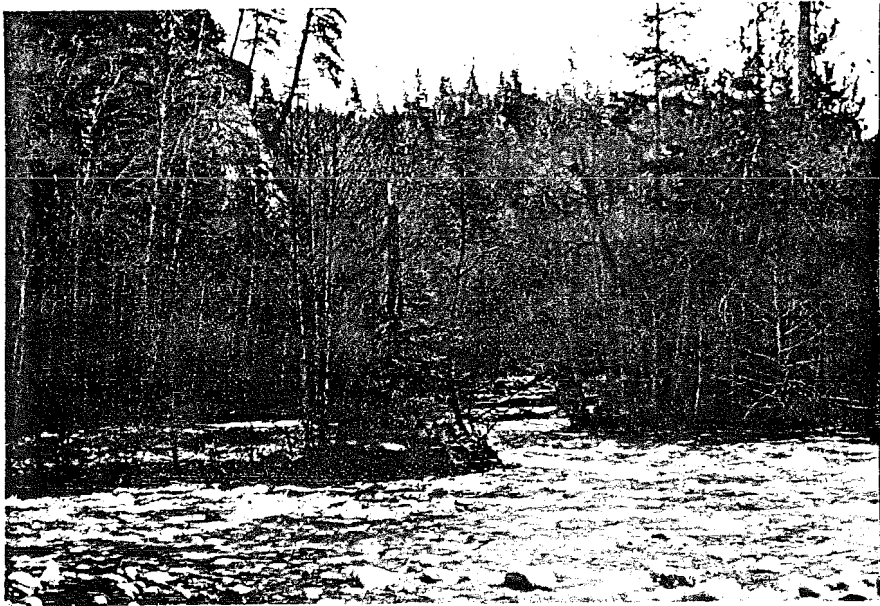
10

10. The island in this stretch is gradually being eroded away due to change in river course
11. Erosion and scouring of the banks is a natural process, but one which landowners would probably try to prevent.
12. Scenic stretch of the river immediately below cliffs shown in Plates 8 and 9. Note low bedrock exposures on both sides, and riparian growth of deciduous trees. Rafting and kayaking could become popular on this and other reaches of the river.

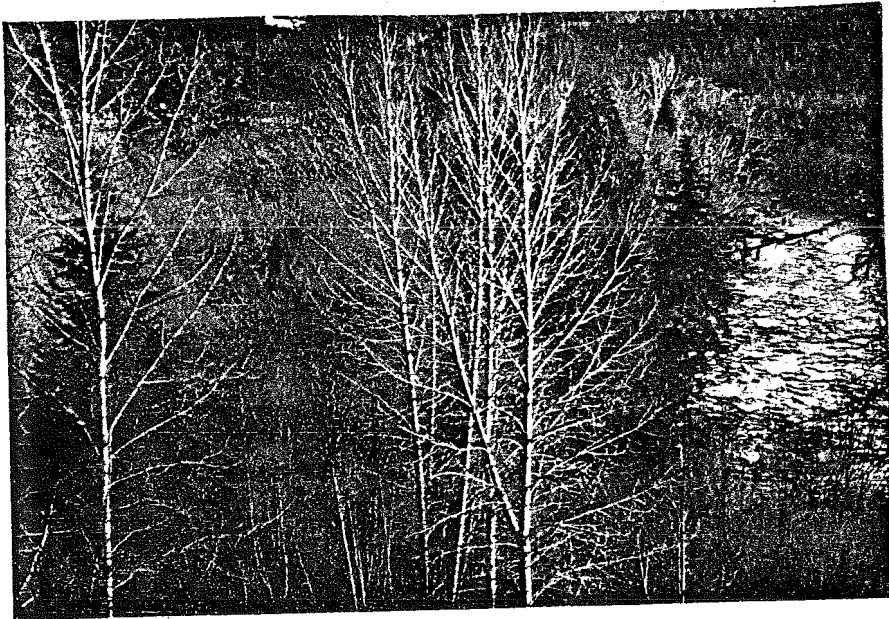
13. High eroded banks. Tree growth in foreground is on floodplain separating river from bottom of bank.
14. Closer view of same bank. Note glacial till surface and consolidated material below. Despite steep and active slope, some trees have gained a foothold.
15. View of river from same banks. Note deciduous riparian fringe along opposite bank (MacMillan Bloedel holdings) and gravel bar. Bars like this become more common from here to Allsbrook Road area.
16. Alder-sword fern association in seepage area near above cliffs.
17. Evidence of overland flow of the river on lower part of floodplain just downstream from cliffs in Plates 13 and 14. Driftwood and silt were deposited during November - December 1975.

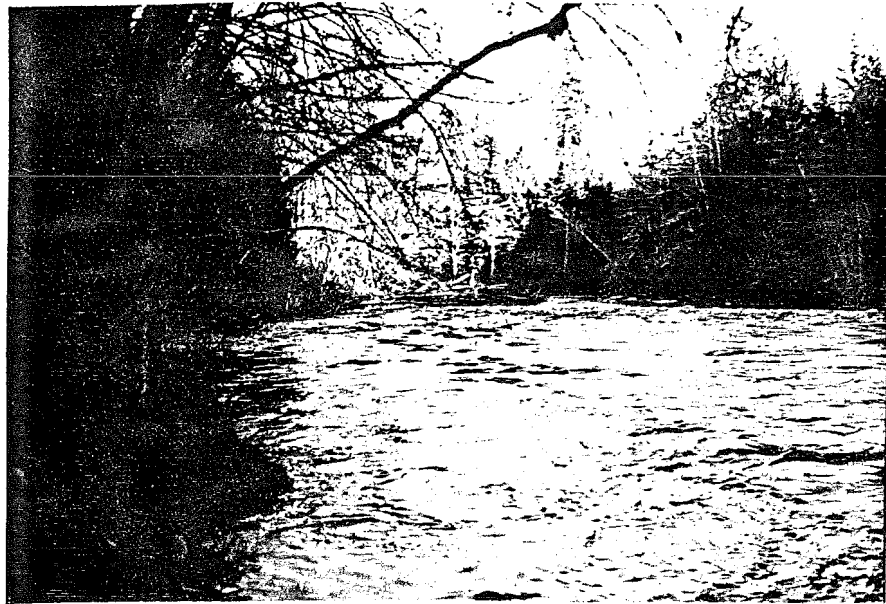
18

18. Englishman at confluence of Morison Creek, which enters on left
19. Attractive floodplain community on opposite bank near confluence of Morison Creek and Englishman River.
20. Morison Creek about one mile above its confluence with the Englishman. Note dense, overhanging deciduous growth, and bedrock exposure in background.

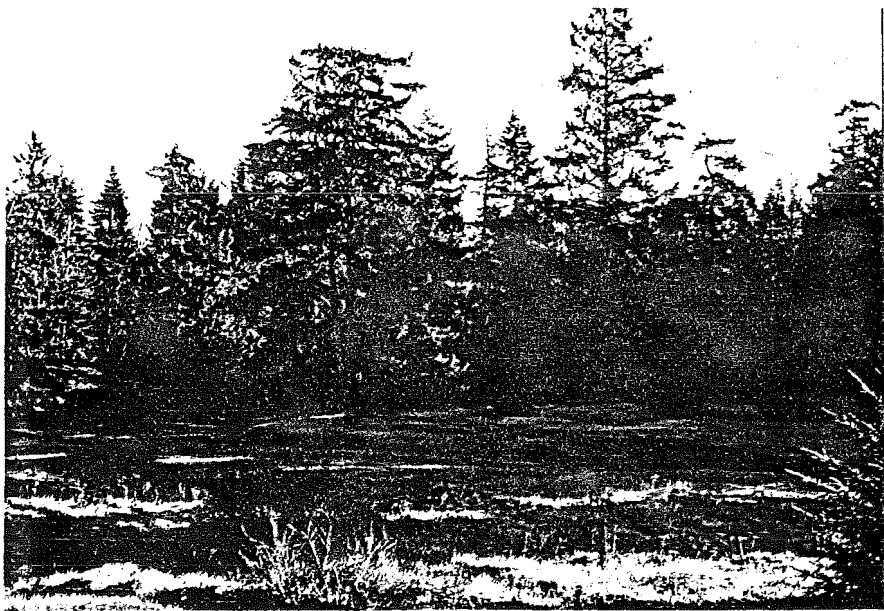
21

21. Forest cover on the higher ground which would be most intensively developed
22. Forest edge, shrub, and open meadow communities
23. The brackish slough which meanders through the open meadows. View is west toward Parksville Arena.
24. Private property immediately below Island Highway which is subject to frequent flooding (not on Aldergrove lands)
25. Depicts scouring and deposition of debris during November - December 1975 adjacent to Aldergrove property, just upstream from the estuary.
26. Accelerated erosion is taking place at this bend in the river (same location as Plate 25). River level had recently reached within 2 to 3 feet of top of bank.
27. Erosion at the upper edge of the estuary, believed to be caused by surface water movement into the river.
28. Soil profile created by erosion shown in Plate 27. Distance from water to ground surface is about 4 feet.

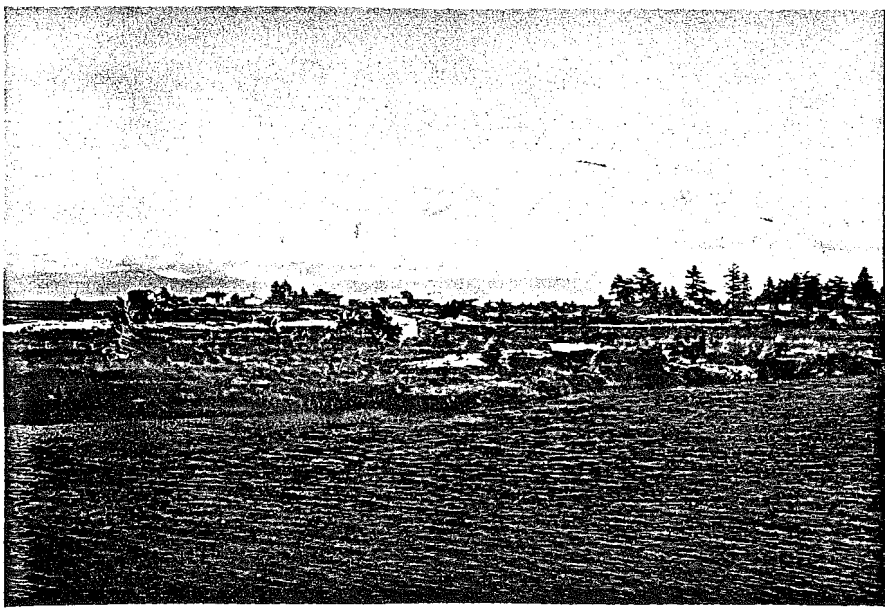
29

29. Looking across estuary from Aldergrove property to housing development on the spit. Estuaries such as this are rare and irreplaceable.
30. Looking from the spit across the mouth of Englishman River to the Aldergrove property and Mt. Arrowsmith. Beach grass communities such as this are also very limited in extent on Vancouver Island.
31. This area at the tip of the spit has high public recreation and conservation values and is barely above high tide level, yet is advertised for sale by a realty company (see Plate 33).

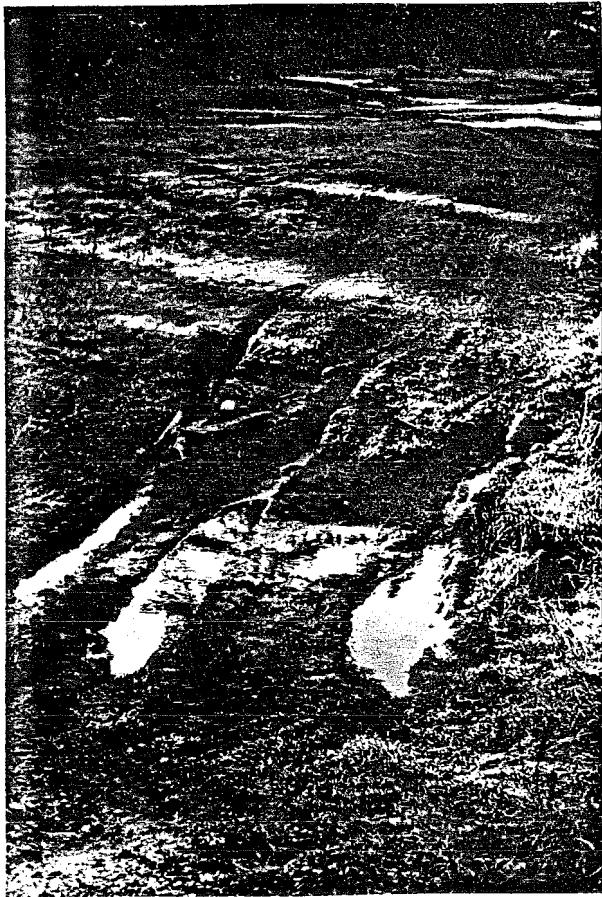
32

32. Vegetation and terrain damage due to unrestricted vehicles on Aldergrove lands.
33. This spit forms the precious barrier between open ocean and estuary. Further modification of it is not recommended.
34. Litter at edge of the Parksville Beach.
35. Housing development on the spit between estuary and ocean. This is not only an ecologically sensitive and recreationally desirable site, but would appear to be at hazard in terms of one year in 100 or 200 ocean storms and river floods.
36. Houses near Arena
37. Abandoned dragline. A historic site?
38. A suitable foreground for one of B.C.'s most attractive beaches?
39. Land filling near the Parksville beach

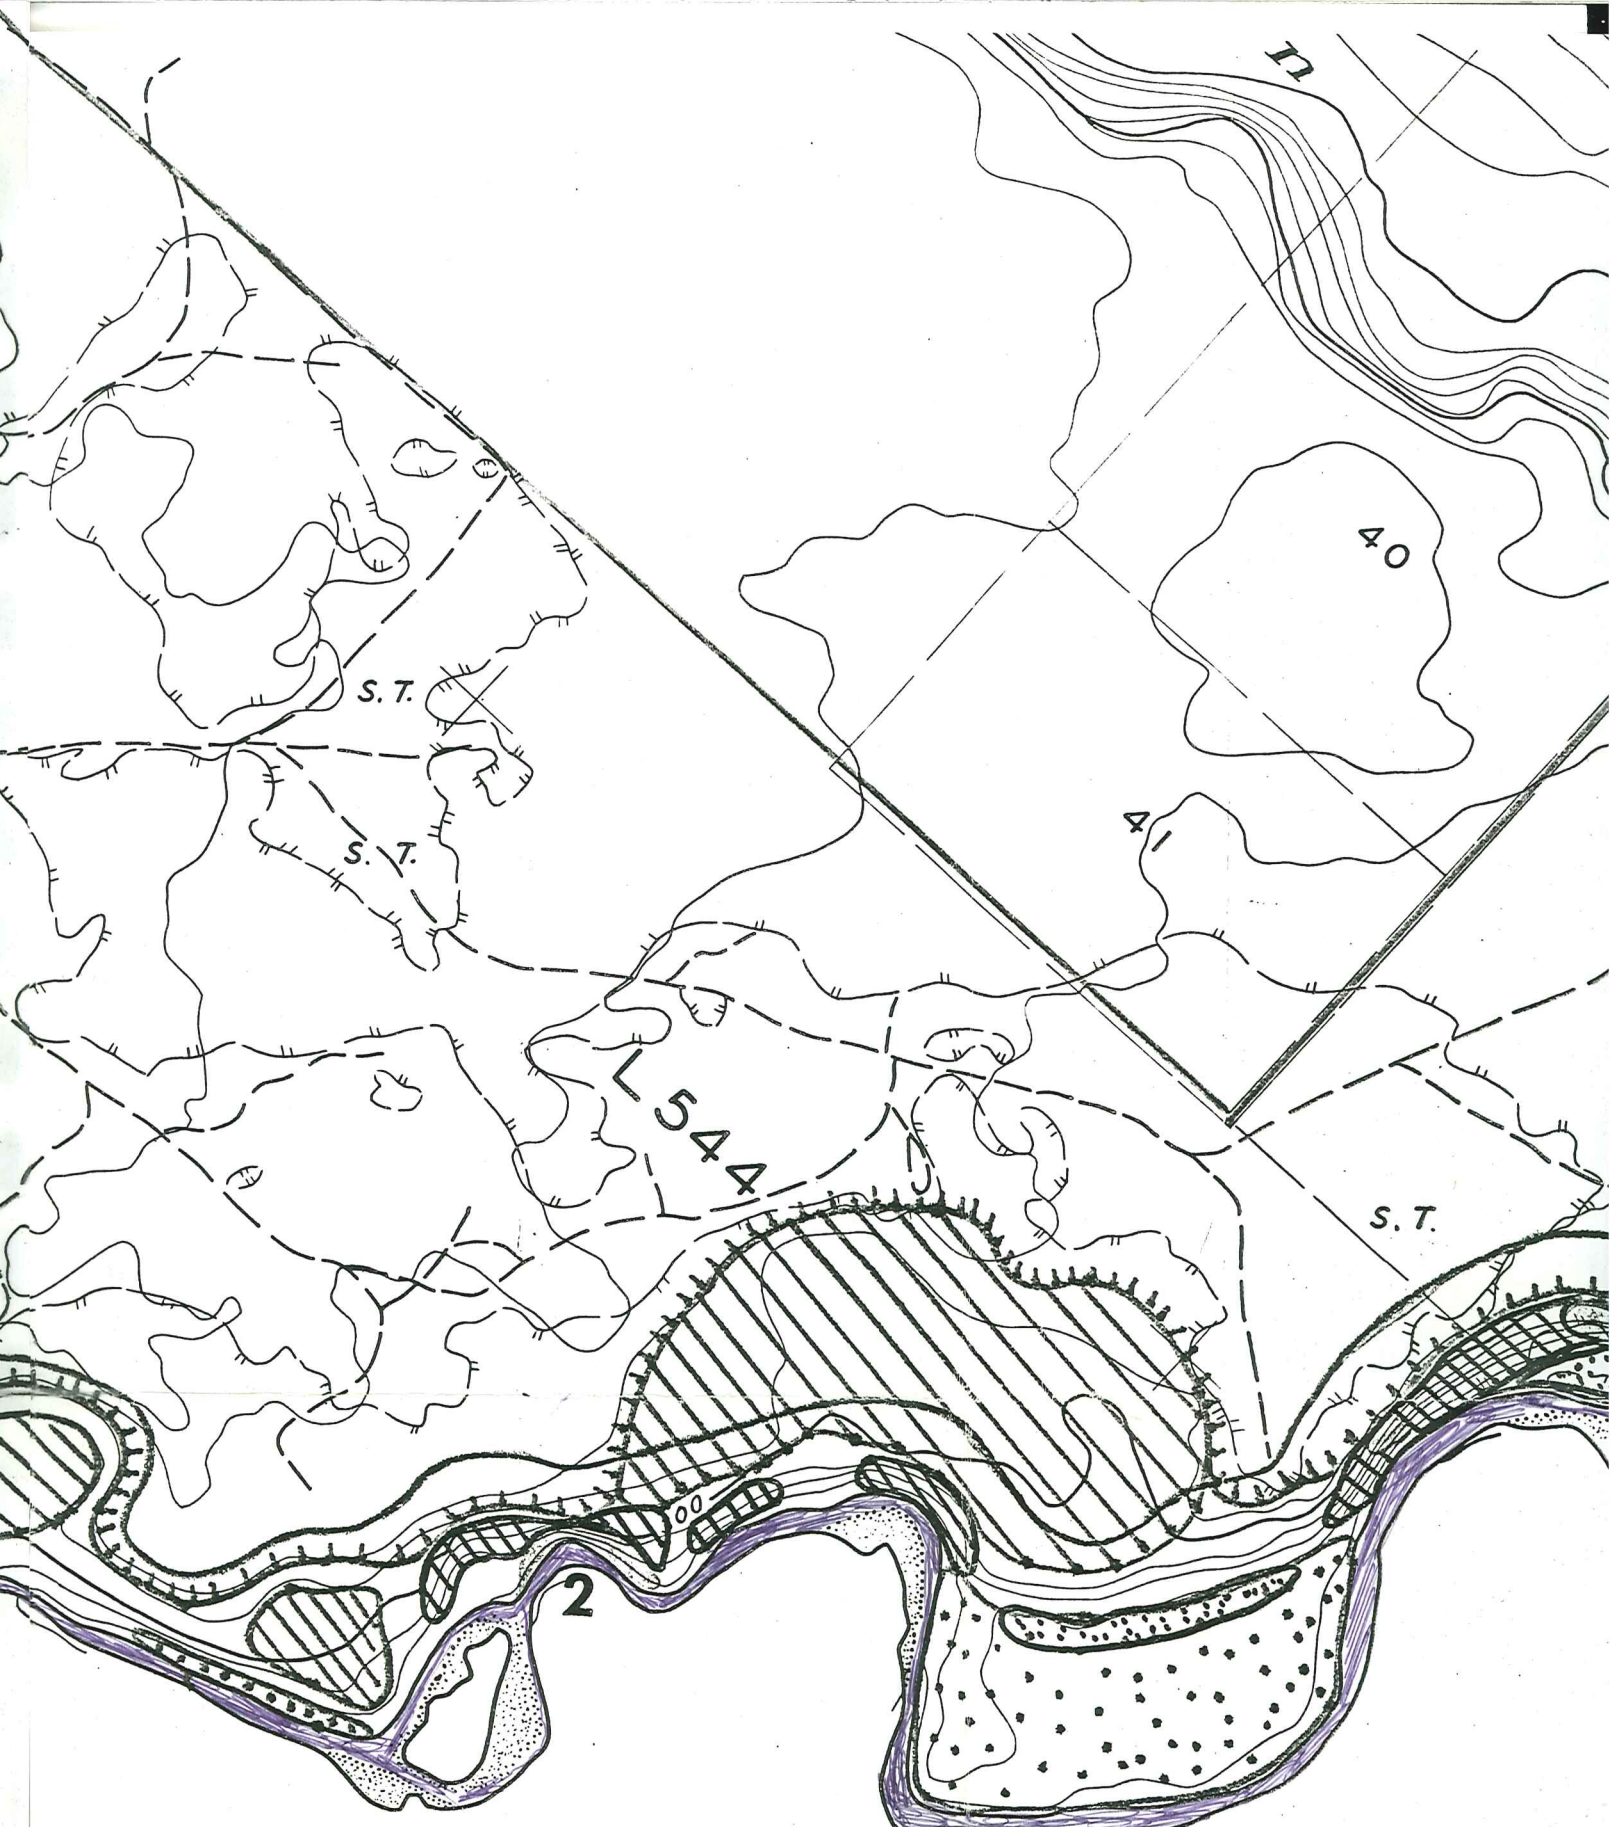
cliffs
 50% slope or greater
 high water table (winter)
 recommended set-back line

The valley banks are not well defined in the area of the confluence of Morison Creek and Englishman River. Here, the recommended setback location (Map No. 1) has been based on ecological distinctness of the vegetation of the plain and valley physiographic units.

2. A recommended setback line at the Allton property is 200 feet beyond the Top of the valley slope where the slope exceeds 50%, and 100 feet where the slope is less than 50%. This applies to frontage on the Englishman and both sides of Morison Creek.
