Enos Lake 2017 Annual Water Quality Technical Report

Introduction

In late February 2017, FW Developments Ltd. contracted BC Conservation Foundation (BCCF) to undertake the first quarter of 2017 water sampling based on parameters and sampling procedures outlined in the *Enos Lake Protection and Monitoring Program* (ELPMP [PGL 2016]). Sampling was completed on March 2, 8, 13, 16 and 23, 2017.

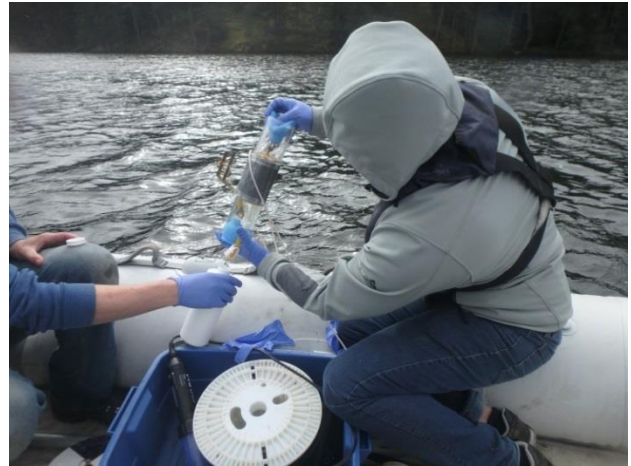
Photo 2: BCCF staff collecting water samples at SWMP-03 (February 2017).

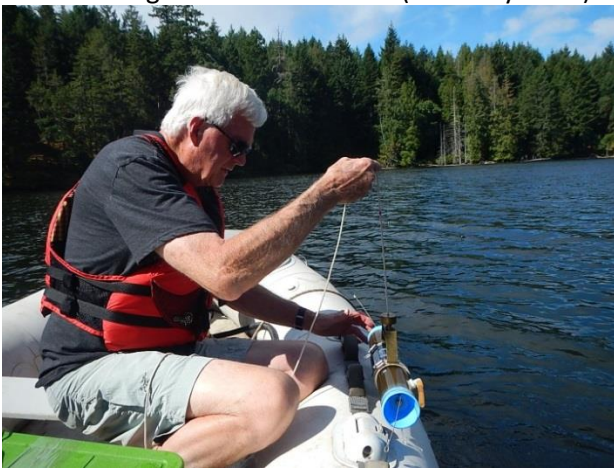
Photo 3: Volunteer deploying the 1 L Van Dorn water sampler at SWMP-03 (August 24, 2017).

Water samples were collected at 1, 5 and 10 m depths. Surface (1 m) samples were collected by hand, and the deep water samples were collected using a 1 L Van Dorn water sampler. Water sampling procedures followed guidelines provided by Maxxam Analytics in addition to the guidelines outlined in the Ambient Freshwater and Effluent Sampling Manual (BC Ministry of Water, Land and Air Protection 2003). Water samples were placed in bottles provided by Maxxam and packed in a cooler with ice and completed COC form. Samples were shipped to Maxxam Analytics in Burnaby for analysis.

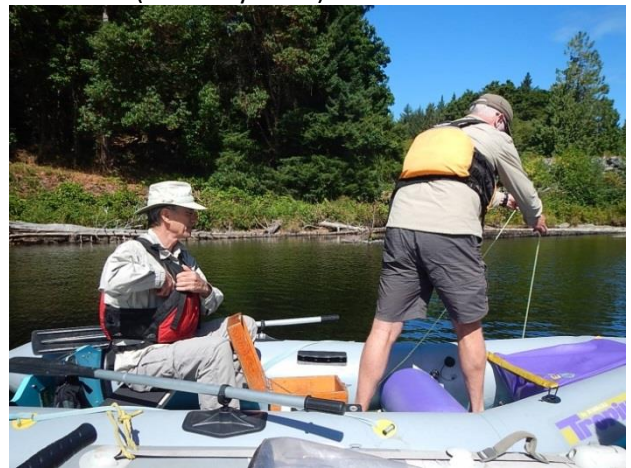
Photo 4: Volunteers deploying the 1 L Van Dorn water sampler at SWMP-03 (August 24, 2017).
