Englishman River Invertebrate Assessment

2019

Summary Report

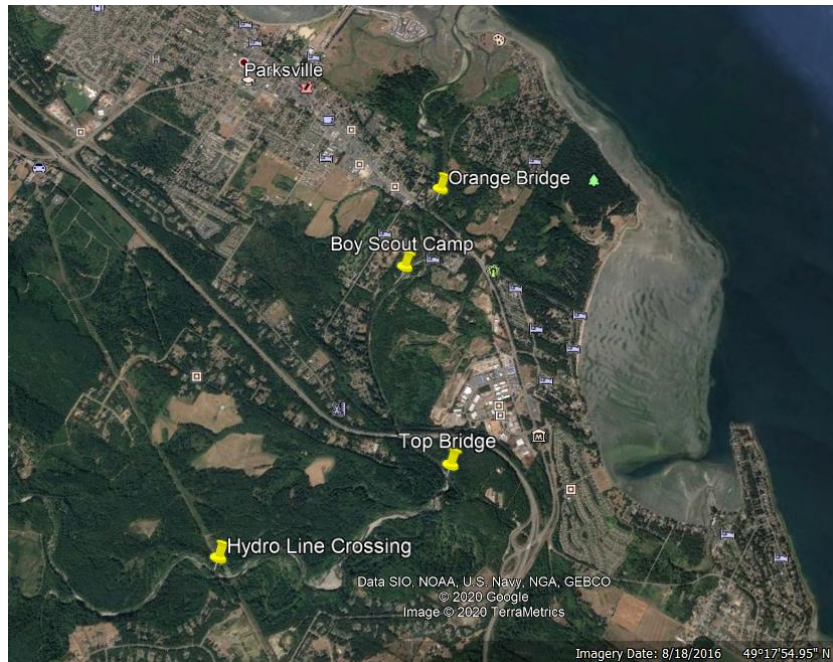
Figure 2. Lower River Sample Sites: Orange Bridge- 200 meters below Hwy. 19A; Boy Scout Camp (off Martindale Road at Despard Road); Top Bridge – outlet of lower pool in Top Bridge Community Park; Hydro Line Crossing (in the Englishman River Regional Park).

Area 1 refers to four sample sites on the mainstem of the lower river (Fig. 2)

- **Site 1.** Riffle 200 meters downstream of the Orange Bridge (access off Plumber Road). Waypoint- 49°19'02.21"N 124°17'05.42"W
- **Site 2.** Riffle adjacent to the Scout Hall (accessed off the end of Despard Road off Martindale Road). Waypoint - 49°18'33.64"N 124°17'01.73"W.
- **Site 3.** Riffle at the tail-out to the last pool in the Top Bridge Park Canyon (accessed from Top Bridge Community Park). Waypoint - 49°17'57.61"N 124°16'03.85"W.
- **Site 4.** Riffle site 100 meters above the BC Hydro Transmission Line Crossing (access from the Englishman River Regional Park). Waypoint - 49°17'07.77"N 124°16'56.99"W

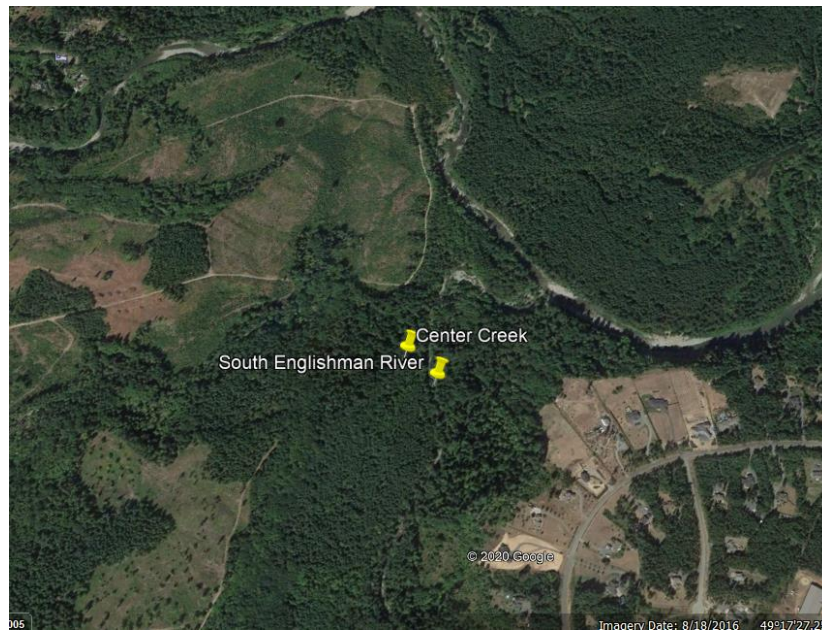
Figure 3. South Englishman River Sample Sites: South Englishman, 200 meters upstream from confluence with mainstem; Center Creek, 100 meters upstream from confluence with Englishman River.

Area 2 refers to two sites located in the **South Englishman River**, entering the river from the southeast (Fig. 3).

- **Site: South Englishman River** - riffle 50 m upstream of the Center Creek confluence. This is the CWM water monitoring site (accessed off 155 Main -). Waypoint - 49°16'34.69"N 124°17'46.93"W
- **Site: Center Creek** – riffle 30 meters upstream confluence with the South Englishman River. Waypoint - 49°16'35.42"N 124°17'51.42"W

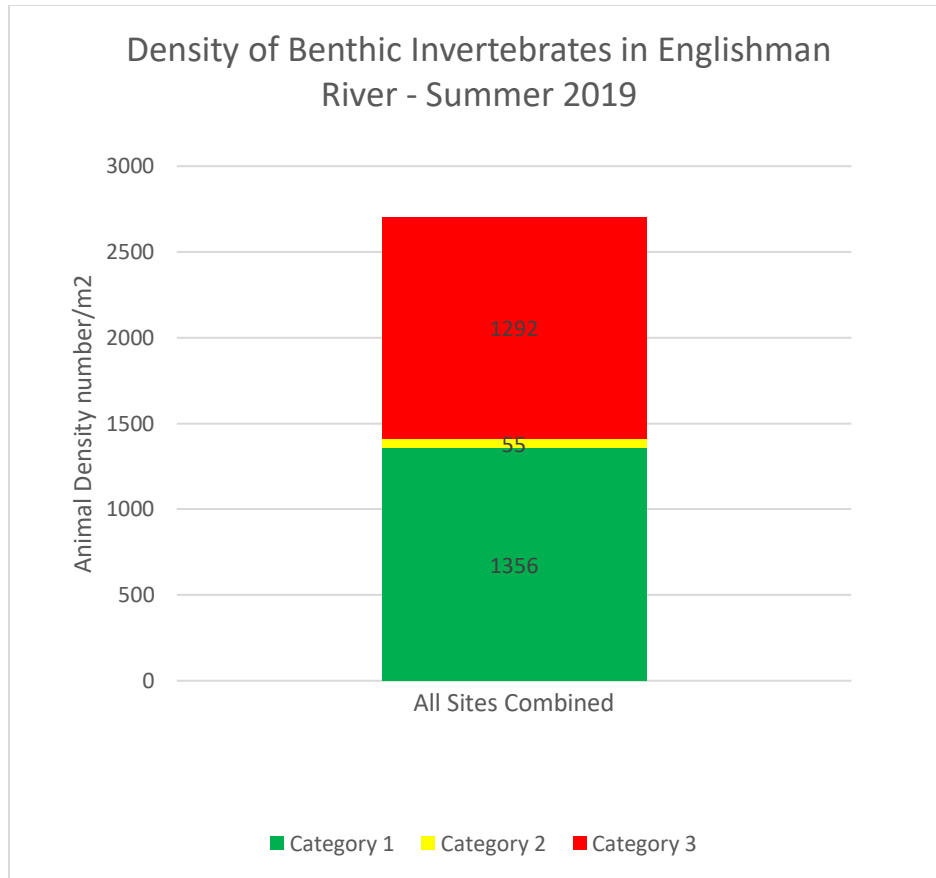
Figure 6. Density of Benthic Invertebrates of the Lower Englishman River watershed sample sites in the summer 2019. Colours represent “pollution sensitive” taxa (green: category 1), “somewhat pollution tolerant (yellow: category 2), and pollution tolerant (red. Category 3).

When combining the counts from all the river sample sites, we see that the total benthic invertebrate density is 2,703 animals/m² (Fig 6). The proportion of benthic invertebrates made up of “pollution sensitive” (category 1) taxa was 50%. Members of the insect groups Ephemeroptera, Plecoptera, and Trichoptera (mayflies, stoneflies, caddisflies, or EPT) are grouped together because they all require clean water (Taccogna 1995).

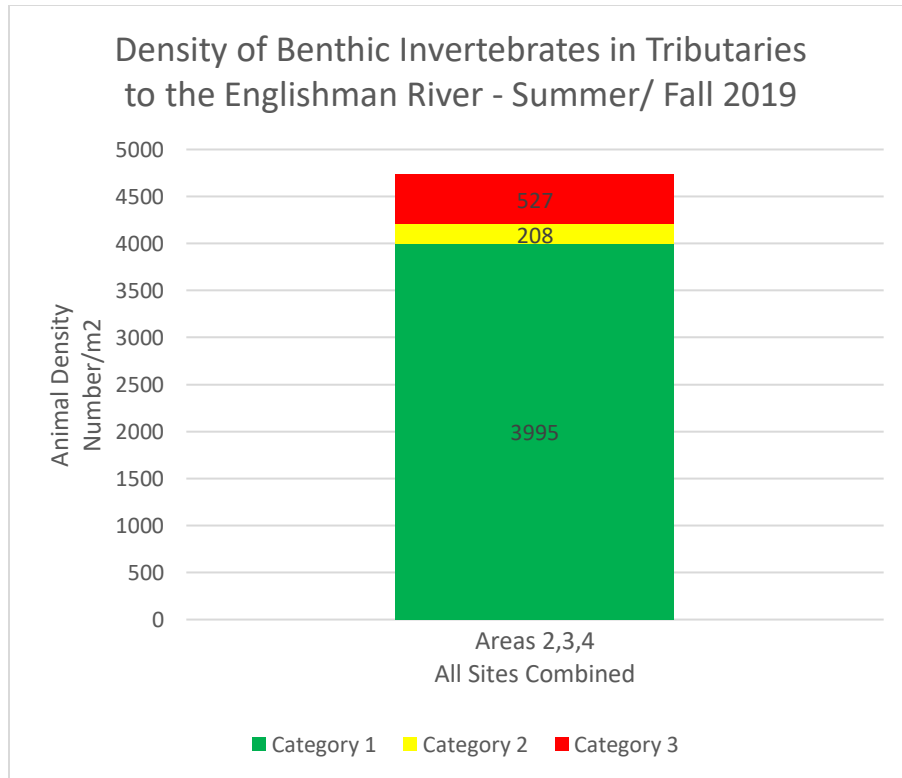
Figure 7. Density of Benthic Invertebrates found in Tributaries of the Englishman River in 2019. Colours represent "pollution sensitive" taxa

The sample sites located on the tributaries were much more productive for benthicinsects with nearly 2x the density (4,473 animals/m²) of river sites. The proportion of category 1 invertebrates is nearly 90%, indicating water quality is very good (Fig. 7).

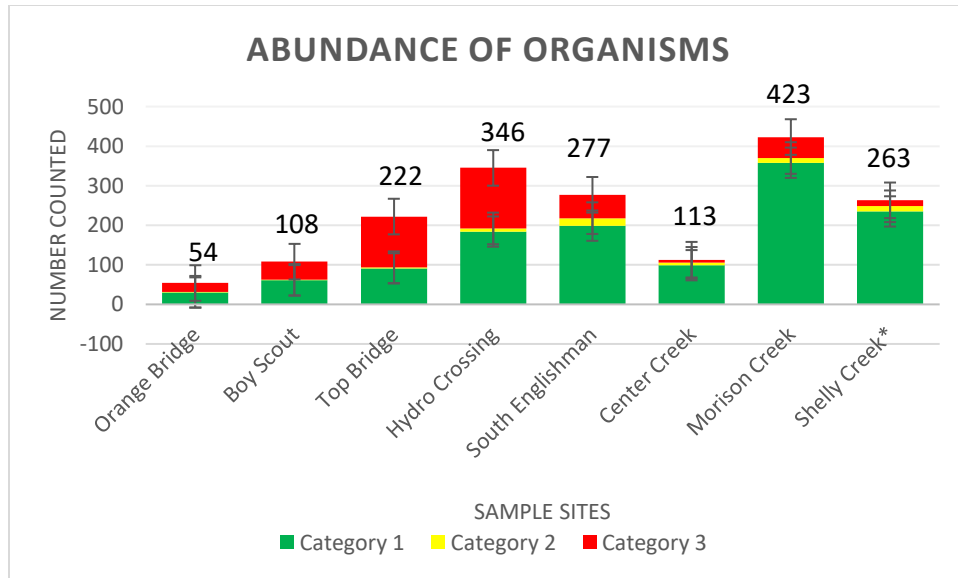
*indicates that only 2 benthic samples were captured

Figure 8. Abundance of Benthic Organisms Counted at each site, grouped into Pollution Sensitivity Categories.

A combined total of 1806 invertebrates were captured at the all sample sites in 2019. Using the number of organisms captured and the pollution sensitivity taxa tallied at each site, there was an interesting trend based on where in the watershed the sample site was located (Fig. 8). The site with the lowest number of organisms was at the Orange Bridge (lowest point in the river sampled). As we moved up the main stem of the river, the total count of organisms multiplied by site 2X at each site. The river site with the highest abundance and diversity of organisms was the hydro crossing, while the tributary with the highest abundance and diversity of organisms was Morison Creek.

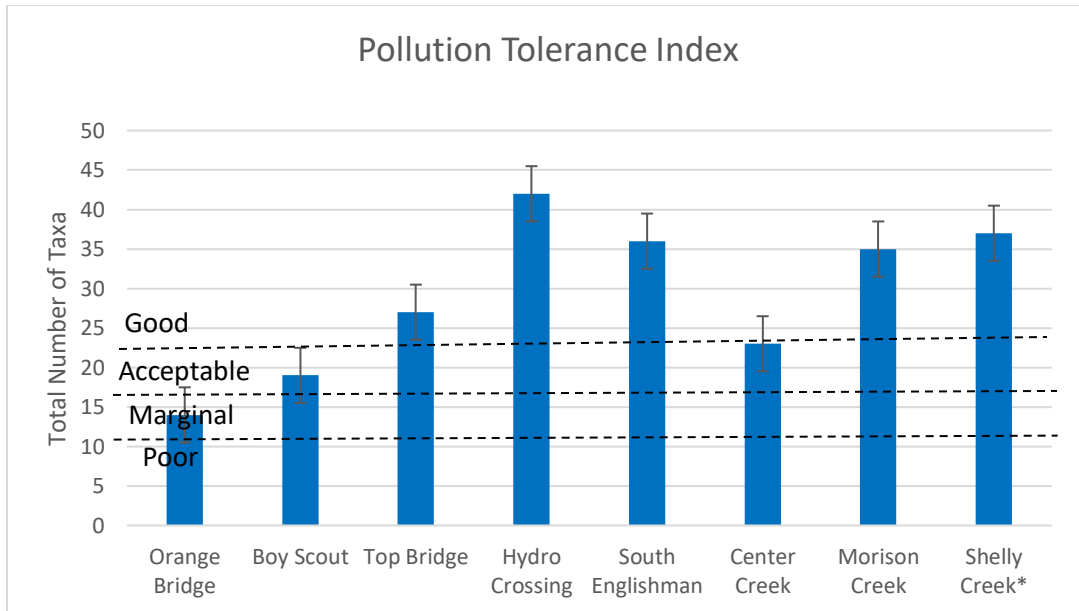
*indicates that only 2 benthic samples were captured

Figure 9. The Pollution Tolerance Index- Rating Water Quality at Sample Sites.

A pollution tolerance index was generated for each site, based upon the total number of broad taxonomic groups found in each pollution tolerance category. The resulting analysis shows that 5 of the 8 sample sites were rated as good, with the lower rated sites found in the lower mainstem of the river (Fig 9).

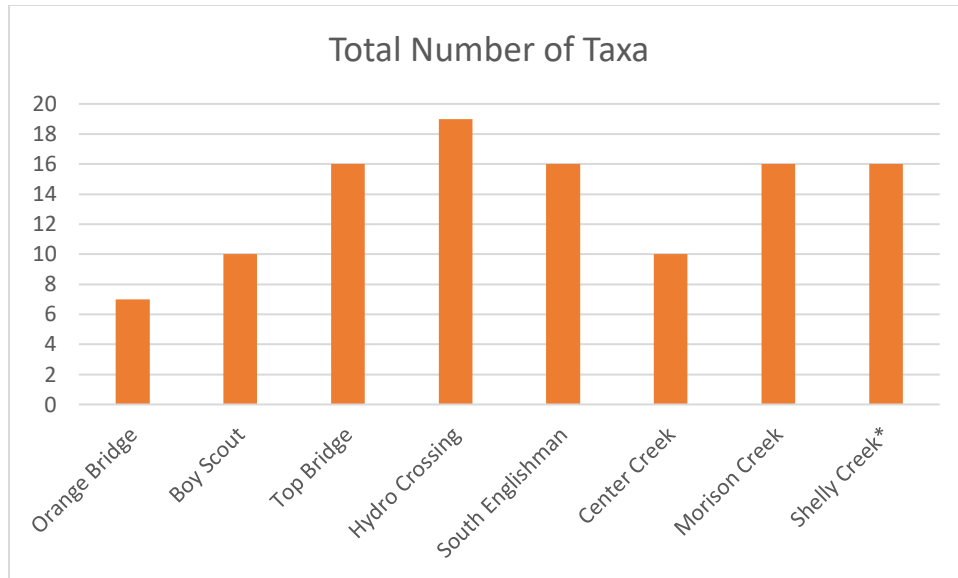
*indicates that only 2 benthic samples were captured

Figure 10. Total Number of Individual Taxa Counted at each Sample Site

The sample sites selected in 2019 show some variability in the total number of taxa counted, from a low of 7 taxon to a high of 19 taxon (Fig. 10). Generally, streams with good habitat and water quality have high benthic diversity; therefore, many taxa (Taccogna 1995). When comparing diversity of sites in the river, we see that the lowest count starts in the lower river and rises at sites further up- river. The tributary sample sites appear to have highly diverse taxa, with the exception of Center Creek, where lower counts could be a result of very low summer flows.

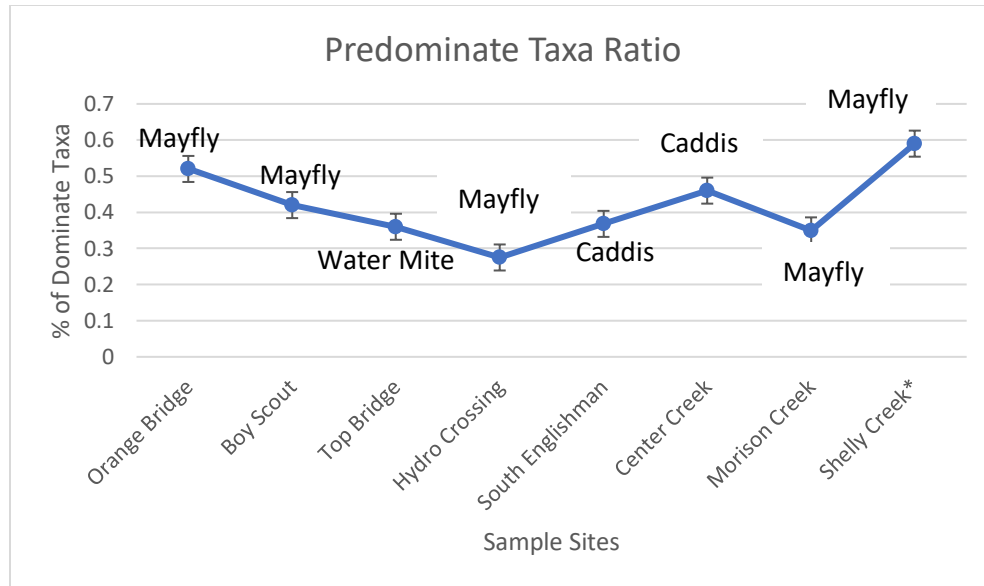
*indicates that only 2 benthic samples were captured

Figure 11. The Ratio of Predominate Taxa and Dominate Species at each Site.

When assessing diversity of benthic invertebrates, a predominate taxa ratio of between 0.0 and 0.4 is rated as good, while 0.4 to 0.6 range as acceptable (Taccogna 1995). The taxa ratio measurements for sites sampled in 2019 ranged between 0.28 to 0.60 (Fig. 11). The predominate taxa for a majority of the sample sites were Mayflies. Water Mite, a pollution tolerant species dominated the Top Bridge sample site. This site is immediately downstream of a popular swimming/bathing location during the summer months.

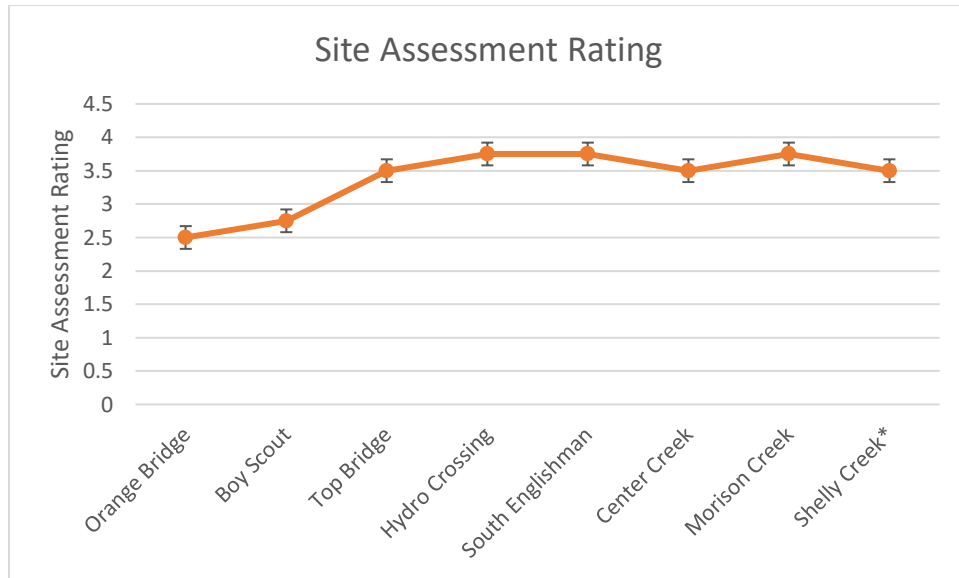
*indicates that only 2 benthic samples were captured

Figure 12. Site Assessment Rating (1=Poor; 2=Marginal; 3=Acceptable; 4=Good).

Site assessment ratings ranged from 2.5 to 3.75 (Fig 12). The lowest site ratings are in the lower river with higher ratings attained at sites further up the river or in tributaries. The combined site rating for all sites in 2019 averaged 3.375. From this analysis we see that “acceptable” conditions exist in the lower Englishman watershed for benthic community abundance and diversity. This rating is similar to the results of the VIU study (Demers 2016).

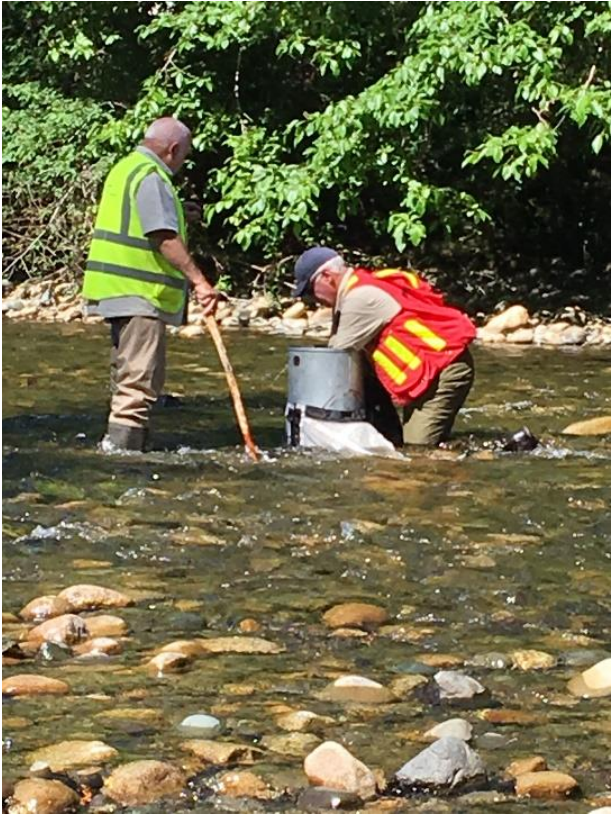
Hess Sampler in use

- b. A “Hess Sampler” was used at the Orange Bridge site. This device is a 34-cm diameter galvanized metal drum hand pressed into the substrate to isolate a circular 0.09m² sampling area (see Appendix II). All stones and debris within the sample drum were gently agitated to loosen any benthic invertebrates. The contents of the collecting net were then transferred to a 20- liter bucket and taken to the field station.

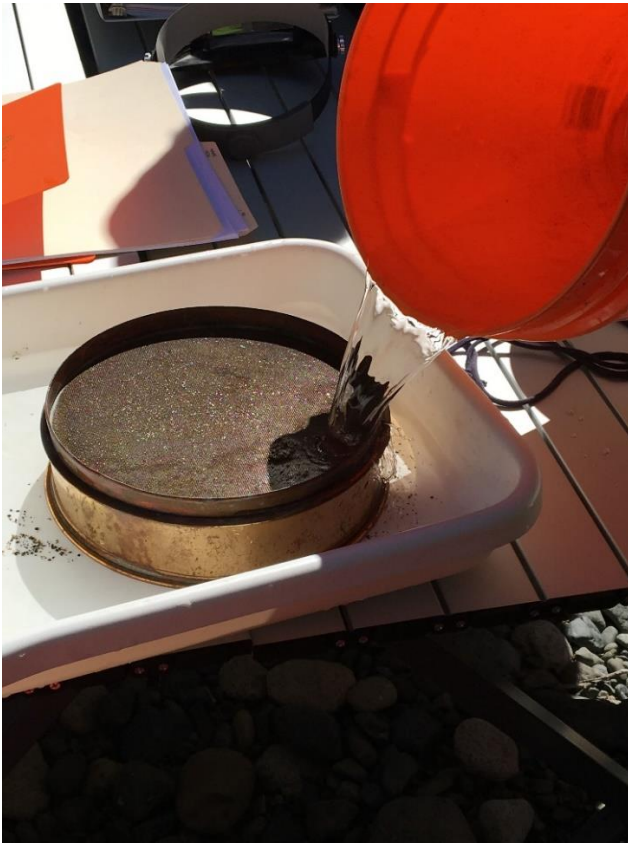
Washing trays to capture bugs in trays

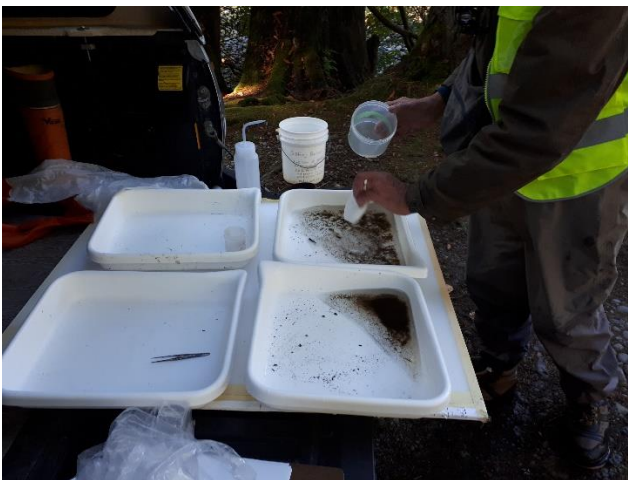
Sample Trays that volunteers used to separate invertebrates from algae and debris.

3. **The process of identifying and counting invertebrates was as follows:** The filtered sample was poured into a white tray (10”x12”) where volunteers sat at a portable table and used a hand magnifying lens to identify bugs. Individual bugs were removed from the trays using tweezers/ pipettes/ eye droppers or white plastic spoons and placed in a plastic ice cube tray. Each compartment of the tray allowed for the sorting of organisms. Bruce Murray was the primary invertebrate identifier. Bruce is familiar with organizing invertebrates as he has an Entomology background. For the project, he would identify bugs to the major taxa or groups (classes orders, families) but not species. Bruce used a head- mounted jewelers magnifying device to identify and count organisms. A laminated field key was also used to help identify organisms (Adams 2003). Bugs that were not easily identified in the field were stored in a small (100ml) plastic bottles using 99% isopropyl alcohol for later identification at home.
