**C.W. YOUNG SIDE CHANNEL
BEAVER POND WETLAND ASSESSMENT
PARK USE PERMIT R2378**

**Prepared for:
Regional District of Nanaimo
Recreation and Parks Department**

**Prepared by:
Mid Vancouver Island Habitat Enhancement Society**

March 13, 2020

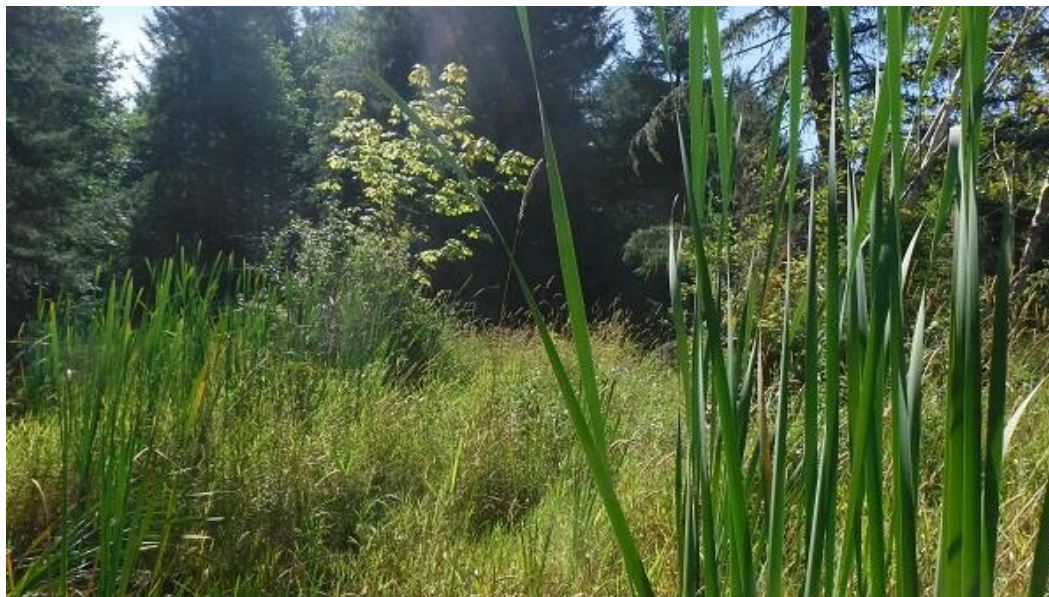
Dominant species are listed for the dominant vegetation forms in Table 3.3. *Phalaris arundinacea*, commonly known as reed canary grass, was by far the most dominant emergent species and had formed dense mats. Since most plots were dominated by emergent vegetation, reed canary grass was the dominant species in the assessment. *Typha latifolia*, or cattail, was the second most prevalent emergent species, however, less than half of the area covered by emergent vegetation in the plots contained cattails. Even in PSP-6 and PSP-7 which contained yellow iris, reed canary grass was the dominant species.

Photo 1. PSP-3, reed canary grass has filled in spaces between cattails.

It appears the reed canary grass in the Beaver Pond is an aggressive variety of the species and is filling in Coho fry rearing habitat while displacing the natural wetland plant species. A management strategy for eradication or control of the grass in the Beaver Pond should be developed by the RDN in partnership with other stakeholders for conservation of fry habitat.

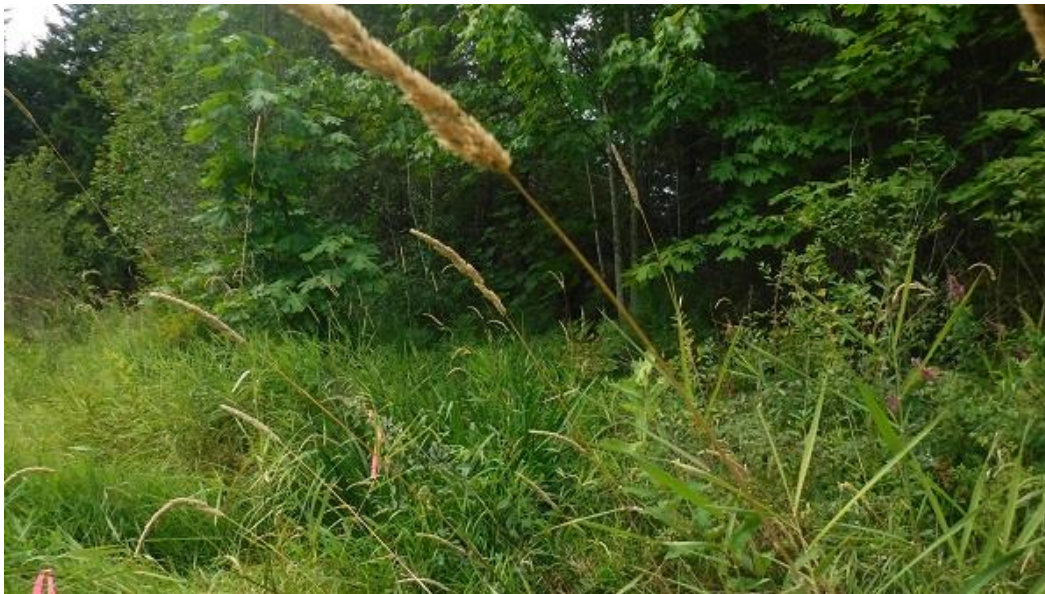
Photo 2. PSP-6, reed canary grass dominates both sides of CM Young Side Channel in Beaver Pond.

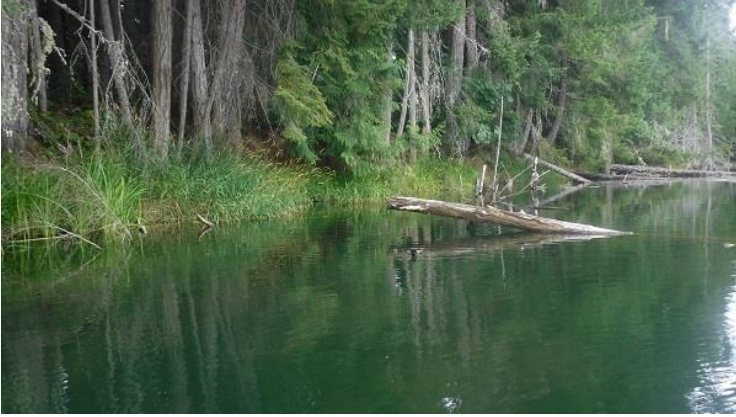
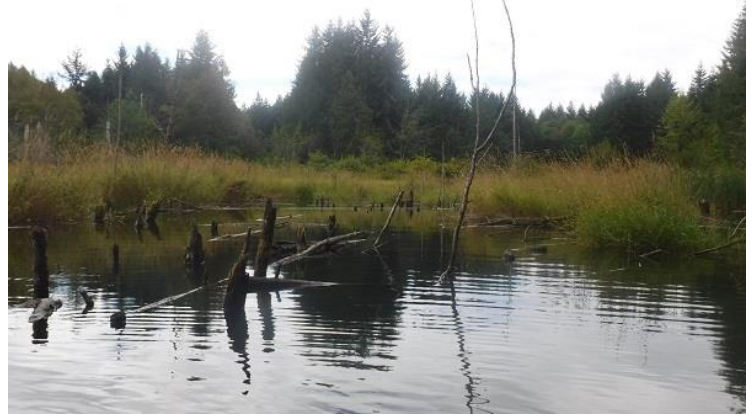
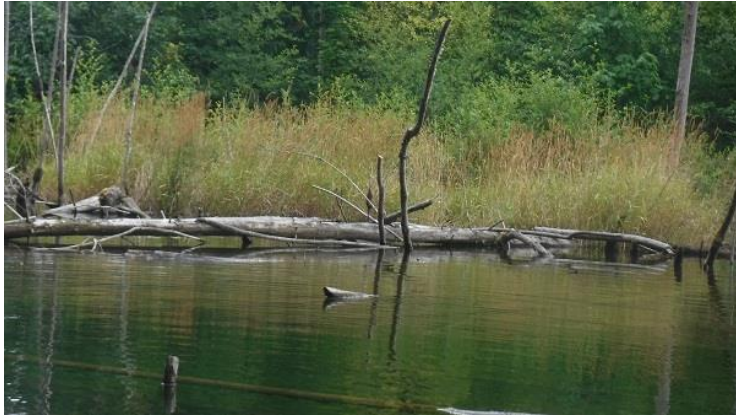
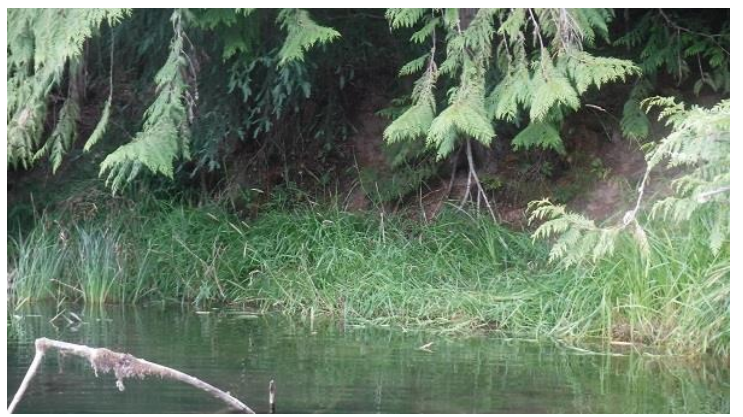
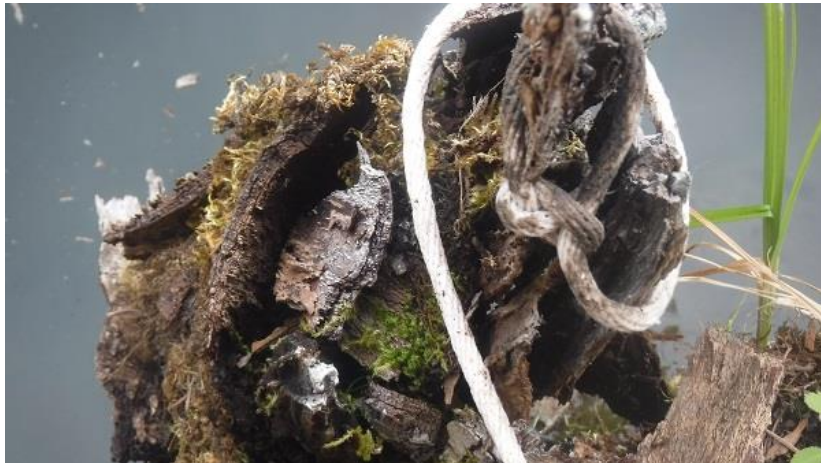
PSP-1 Photos

NOTES: due to difficulty in navigating canoe through deadfall in water a new location was selected. 15 % of the plot was unvegetated pond bottom, 75% of plot was pond bottom covered in 2 algal types 10% of plot had tree stumps sticking out of water, 30% of plot had woody debris on pond bottom covered in algae

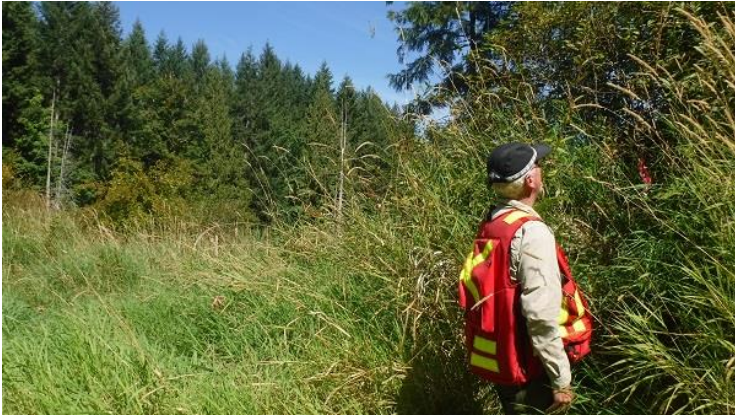
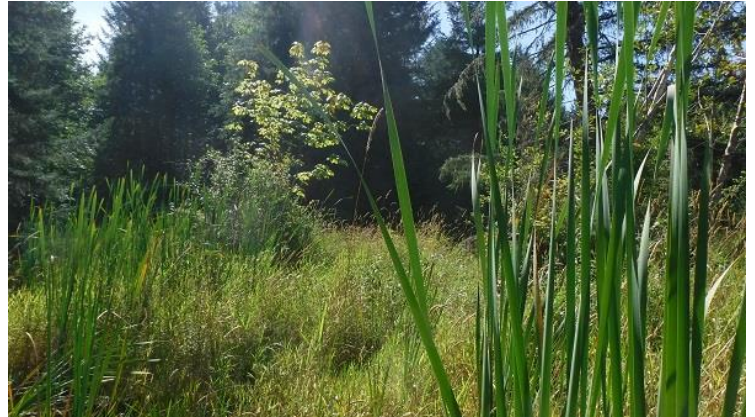
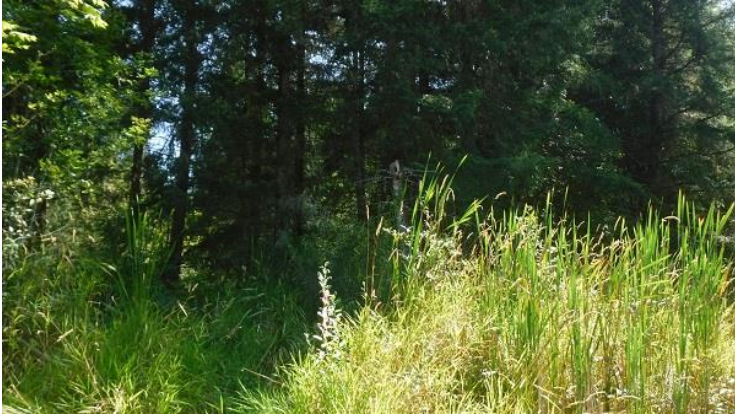
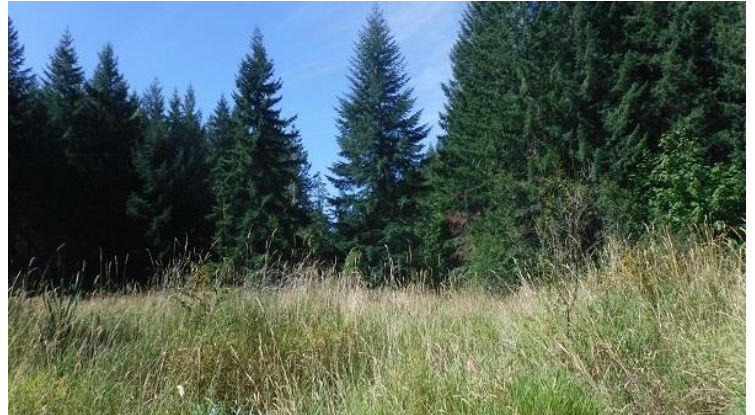
PSP-3 Photos

NOTES: other species include cattails, huckleberry and elderberry
logs have vegetation growing on them

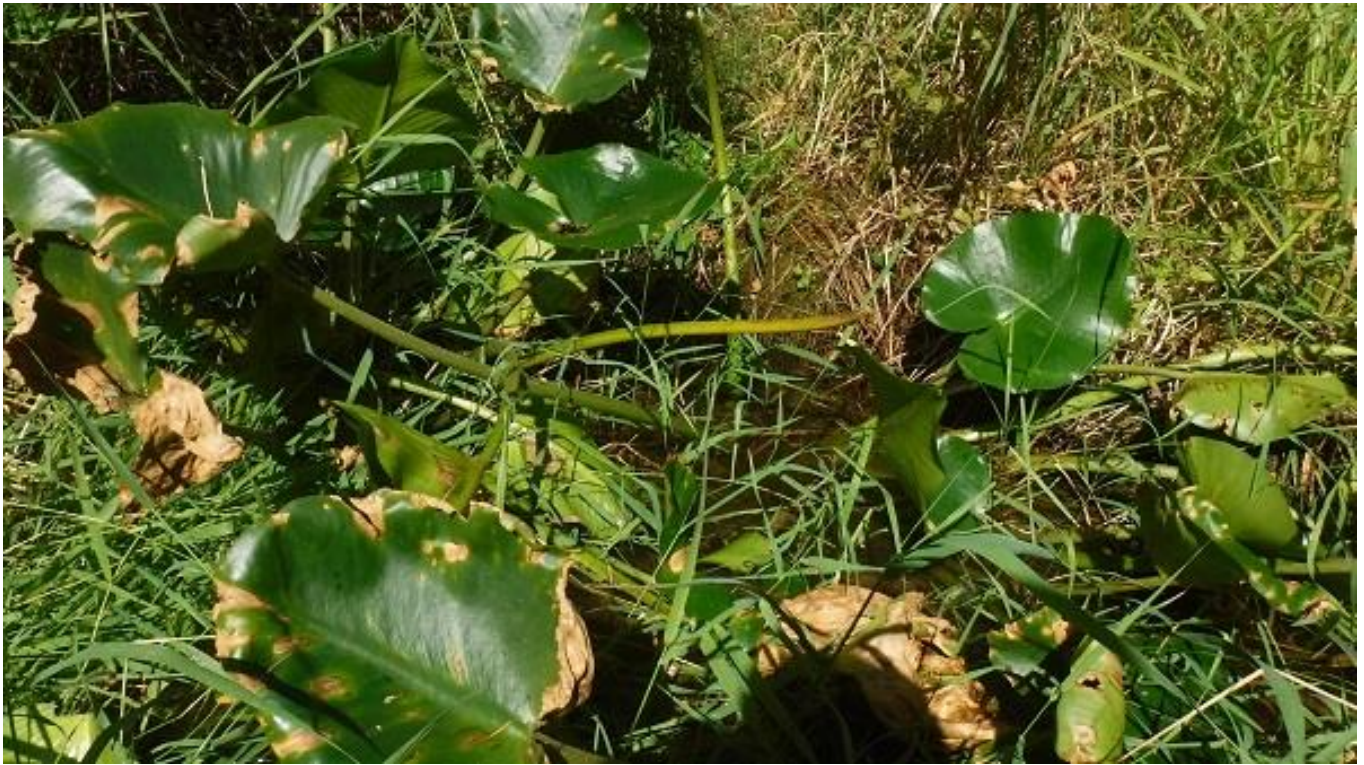
Yellow Pond Lily near plot centre

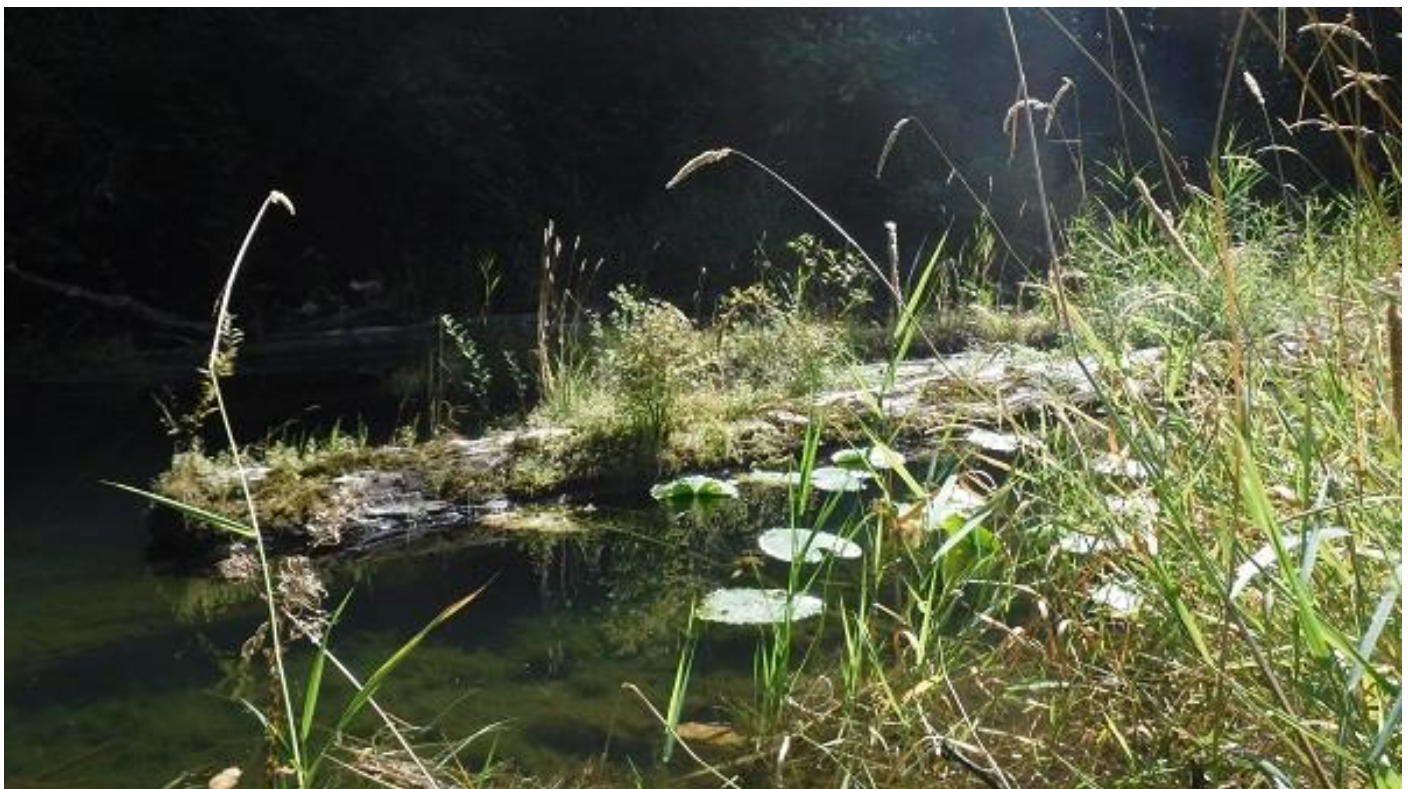
Open Water was present in all sample sites but only PSP-1 and PSP-4 contained Coho fry at the time of assessment (Appendix 3). The vegetation attribute common to both sites was submergent vegetation that covered 30 percent and greater of the plot area. The next highest amount of submergent vegetation in a plot was only 5 percent. It is interesting to note that, although PSP-5 and PSP-7 had similar amounts of Open Water as PSP-4 (Table 3.1), the cover by submergent vegetation in those plots was significantly less which might explain the absence of Coho fry.

Open Water on east side of plot (2 Coho fry observed)

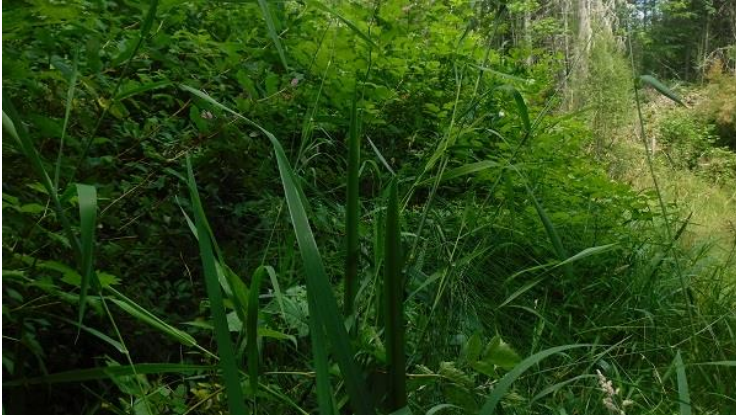
North – Yellow Iris in view

The status of invasive plants in the wetland will be updated, including examining PSP-6 and PSP-7 for signs of yellow iris regeneration. Flowers and seed heads will be removed from any regenerating plants, and the RDN immediately notified.
